# Manhole Inspection Summary

Manhole # S4900\_011MH

**Location** Address: **Lyndale ave**

Cross Street: **Belair rd**

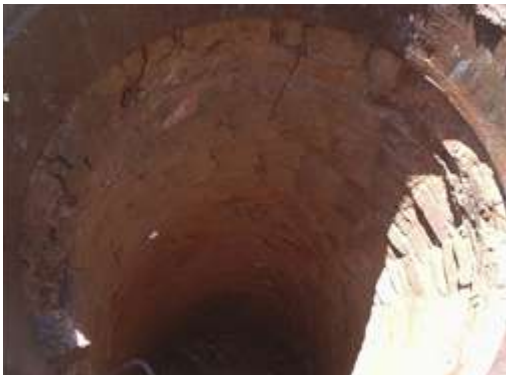
Defect 1

Infiltration: ☐ None ☒ **Joint** ☐ Cracks ☒ **Mortar** ☐ Roots ☐ Wall

infiltration

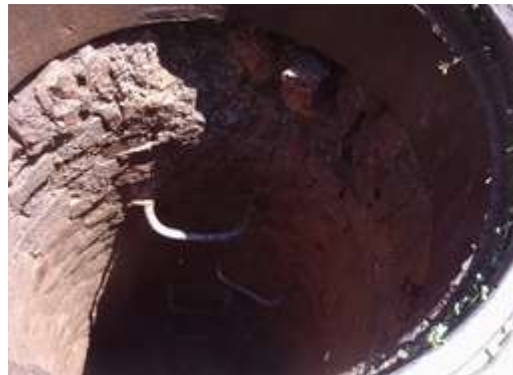
Defect 2

Condition: ☐ Sound ☐ Cracked ☐ Root Intrusion ☒ **Loose Brick** ☐ Deteriorated

deterioration

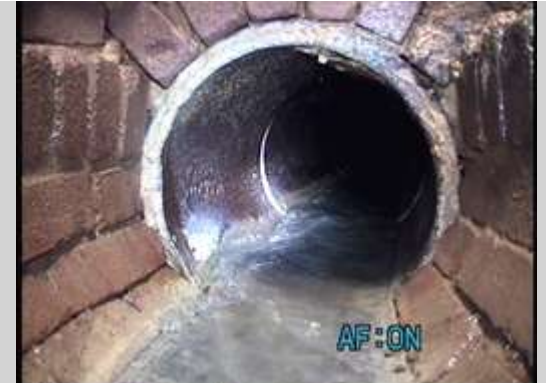
12 O'Clock Outflow

12 in. Circular Gravity Sewer  
Pipe Out @ 12 O'Clock

Pipe Height: **12** (in.) Rod and Bar (Angled)  
Pipe Material: **Clay** ☐ Pipe Lined  
Invert Depth: **13.05** (ft.) Flow Characteristics: **Fast**  
Deposits: ☒ None ☐ Mud ☐ Sludge ☐ Debris ☐ Grease  
Silt Depth: (in.) Deposits Extent:  
Infiltration: **None** Pipe Seal Cond: **Sound**

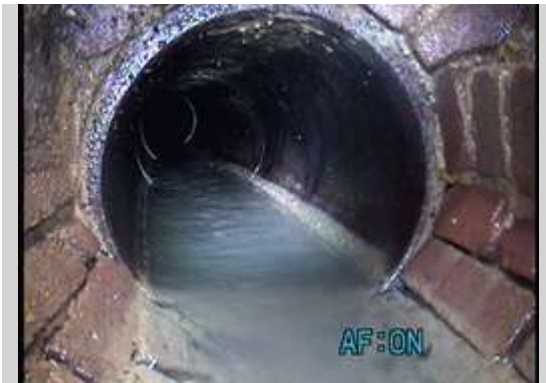
5 O'Clock Inflow

10 in. Circular Gravity Sewer  
Pipe In @ 5 O'Clock

Pipe Height: **10.8** (in.) Rod and Bar (Angled)  
Pipe Material: **Clay** ☐ Pipe Lined  
Invert Depth: **12.90** (ft.) Flow Characteristics: **Fast**  
Deposits: ☒ None ☐ Mud ☐ Sludge ☐ Debris ☐ Grease  
Silt Depth: (in.) Deposits Extent:  
Infiltration: **None** Pipe Seal Cond: **Sound**
